Has the high water altered the bed of the Meuse?

Update: 31-8-2021

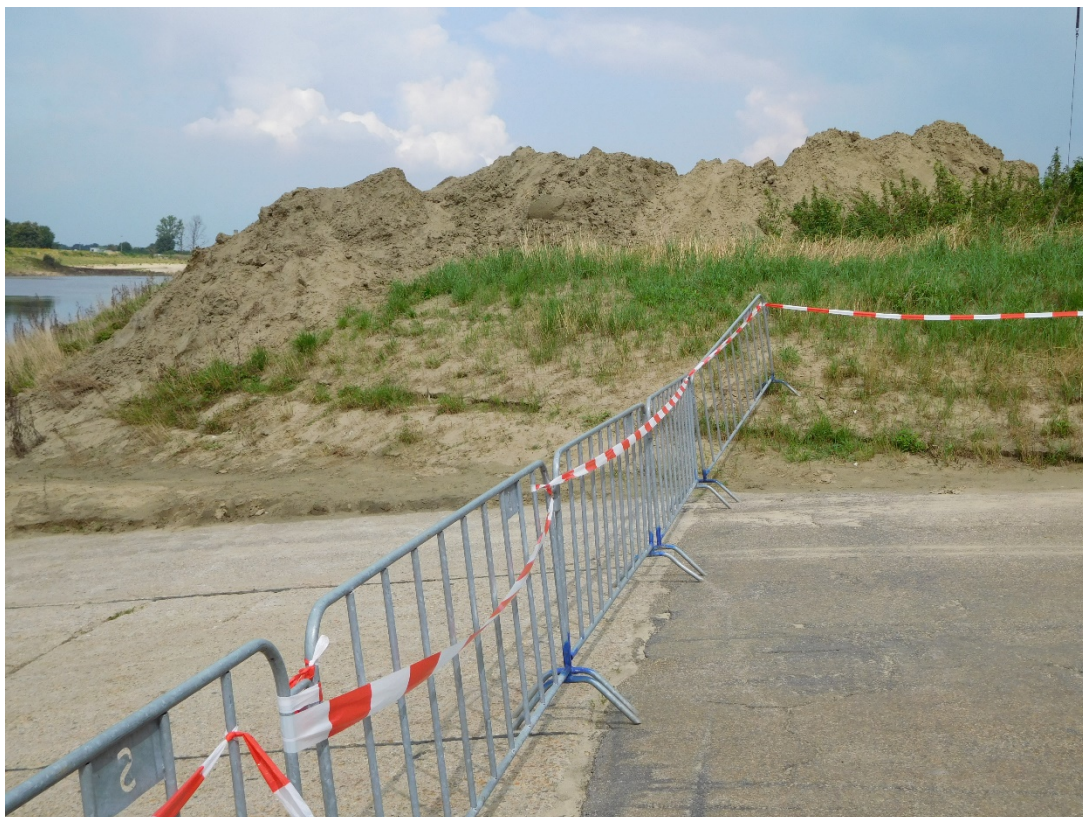
Sand deposits near the Berg aan de Maas ferry (km 38.9), still visible in the grass after being moved to the side when sand was removed from the ferry threshold.

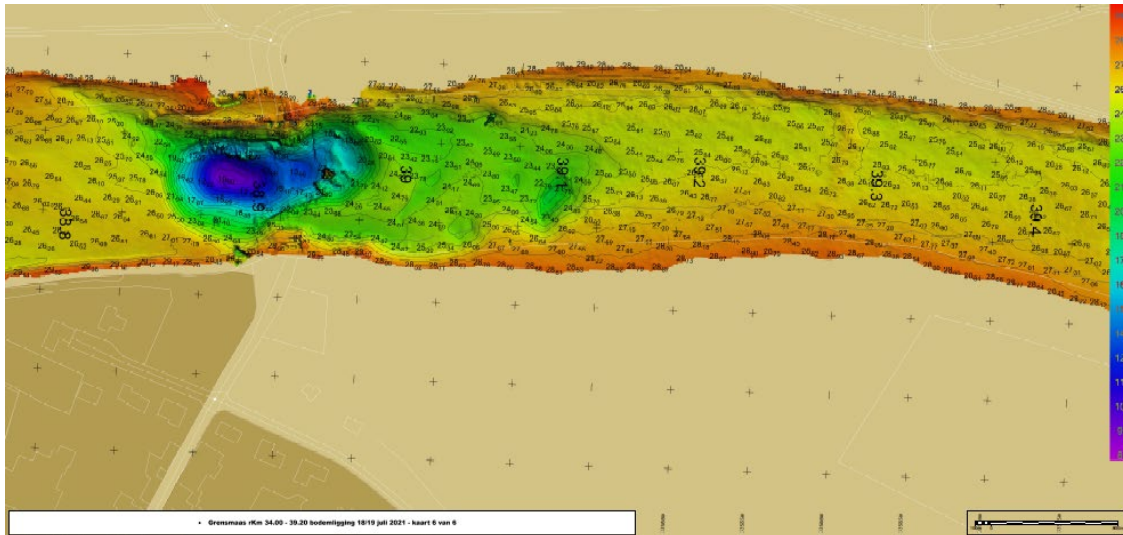
However, the bed does not recover naturally if the erosion occurs after a limit to the strength of a bed or bank has been exceeded. This is the case, for example, if a bank defence fails or if a thin layer of gravel starts to move and covers layers with finer sand. Deep scour holes can then form suddenly. In the steep and fast-flowing Grensmaas, this is a threat between kilometres 17 and 45, where fine-grained Tertiary sands are located close below the surface. As a result, various scour holes formed during the high water of July 2021. At Berg aan de Maas (km 38.9) the bed eroded to a level below

10 m NAP, resulting in a pit extending below the surrounding river bed to a depth equivalent to a four-storey flat.

Scour hole extending to below 10 m NAP near Berg aan de Maas (km 38.9) (source: Rijkswaterstaat).

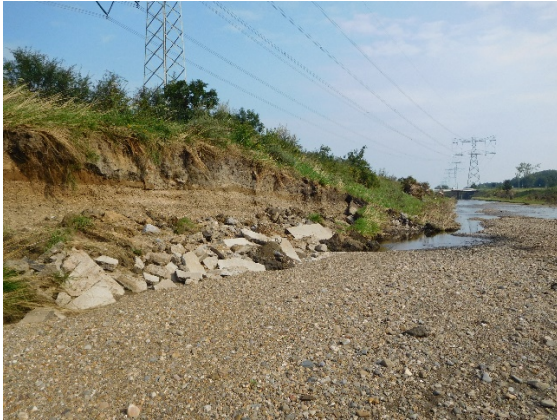
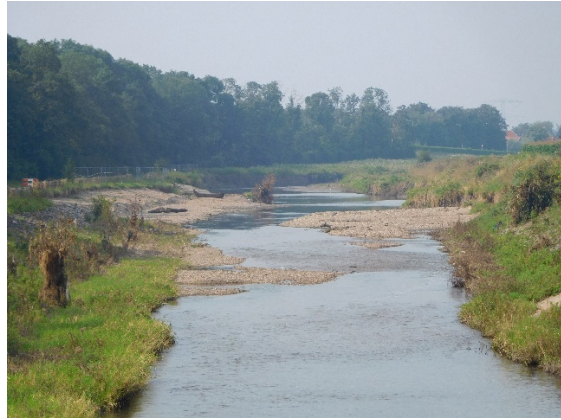
In normal circumstances, banks erode mainly on the outer bends where the bed is deeper and the water flows faster, and in places where ships manoeuvre or sail close to the bank. During periods of high water, bank erosion makes the flow cross-section wider, particularly where the flow narrows. Banks also erode during high water where the current flows out of the summer bed to take a path of less resistance across the winter bed, for example through ponds in the winter bed or a shortcut that cuts off a bend. Erosion on a new path of this kind may be the precursor to a change in the course of the river ([Emriver river gravel mining demonstration. - YouTube](#)). Indications that this was happening were seen after the high water in July 2021 along the Old Meuse, which forms the lower reaches of the Geleenbeek river.

Bank erosion along the Old Meuse, or the lower reaches of the Geleenbeek river, in the winter bed of the Meuse.
