A sustainable solution for massive coastal erosion in Central Java

~ Towards Regional Scale Application of Hybrid Engineering ~
Discussion paper

February 2014

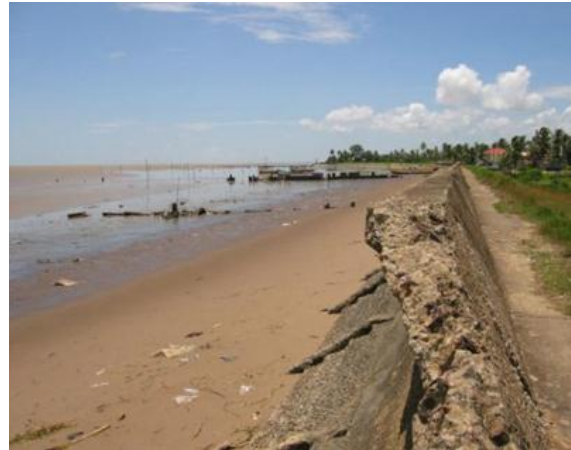
*Figure 2. a collapsed structure in British Guyana
(photo by H. Winterwerp)*

Major investments have been made in traditional infrastructural responses – dams, sea-dykes and groins – in an attempt to resolve these problems. In most cases these failed to provide the desired protection and did not result in sufficient improvements in human welfare and economy (Figure 2). Often hard-infrastructure solutions aggravate erosion problems and subsidence due to unanticipated interferences with sediment flows and soil conditions⁷. Moreover, they do not revive the mangrove values that were lost. Mangrove belt establishment has been widely promoted as an alternative means to enhance coastal resilience. However, mangroves can only be successfully restored if the regional shoreline morphology (sediment flows, bathymetry etc.) and connection of the system to the river is to some degree rehabilitated as well. Most rehabilitation pilots do not reinstate these abiotic conditions. As a consequence they fail to stabilise eroding coastlines. Along many stretches of coast there is no response at all: they continue to degrade at an alarming rate.

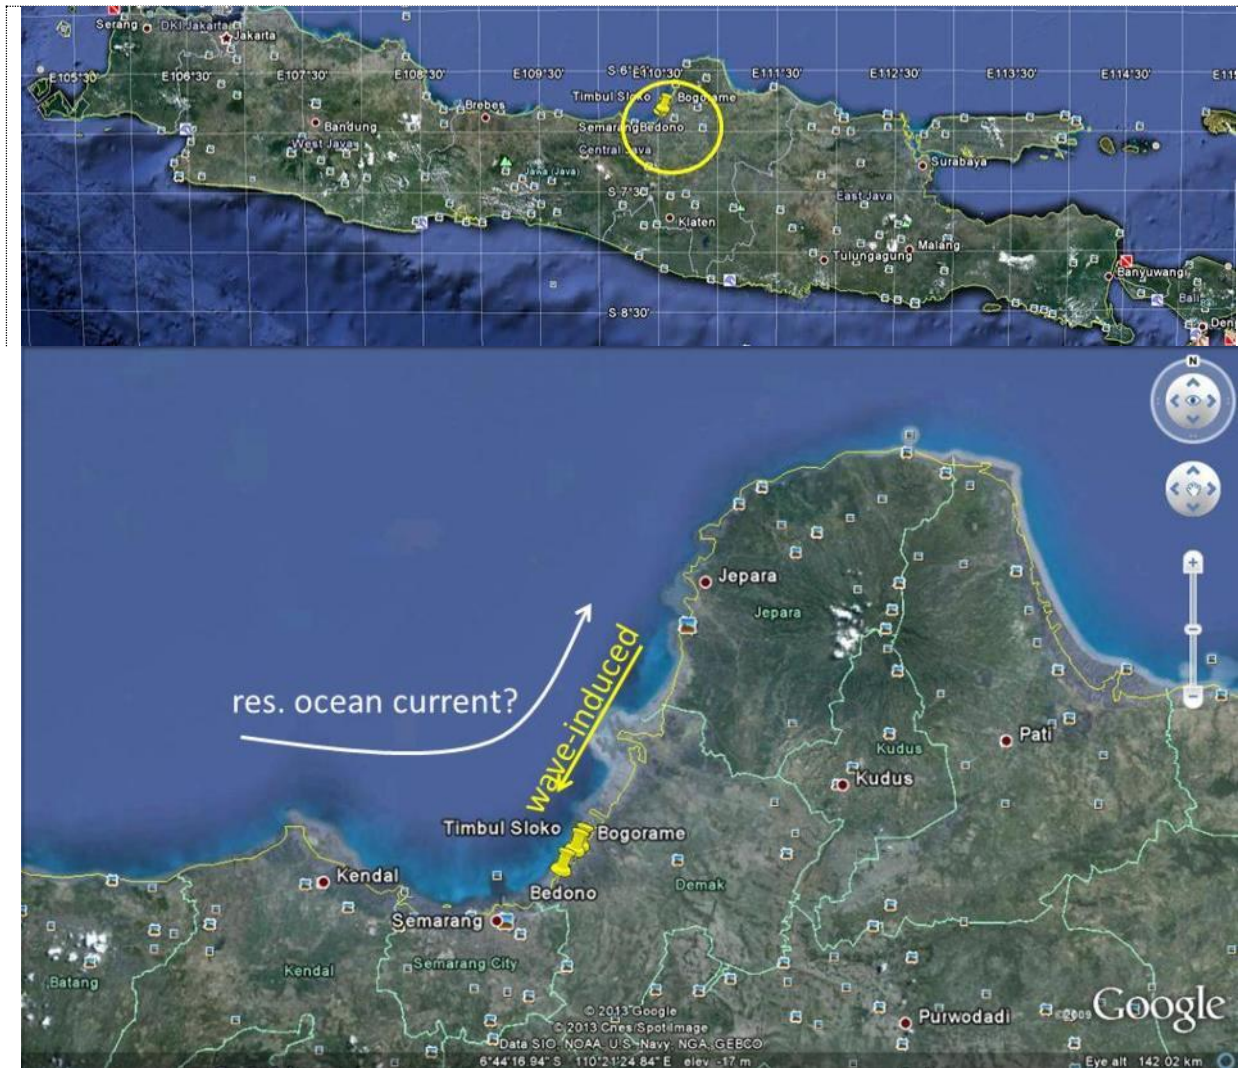
Figure 4: Java with Demak coast indicated by yellow circle (upper panel) and close-up of Demak district and coastline (lower panel), including indications of residual sediment transport.

through the MMAF Resilient Village if the approach proves to be successful. See Figure 4 for the exact location.

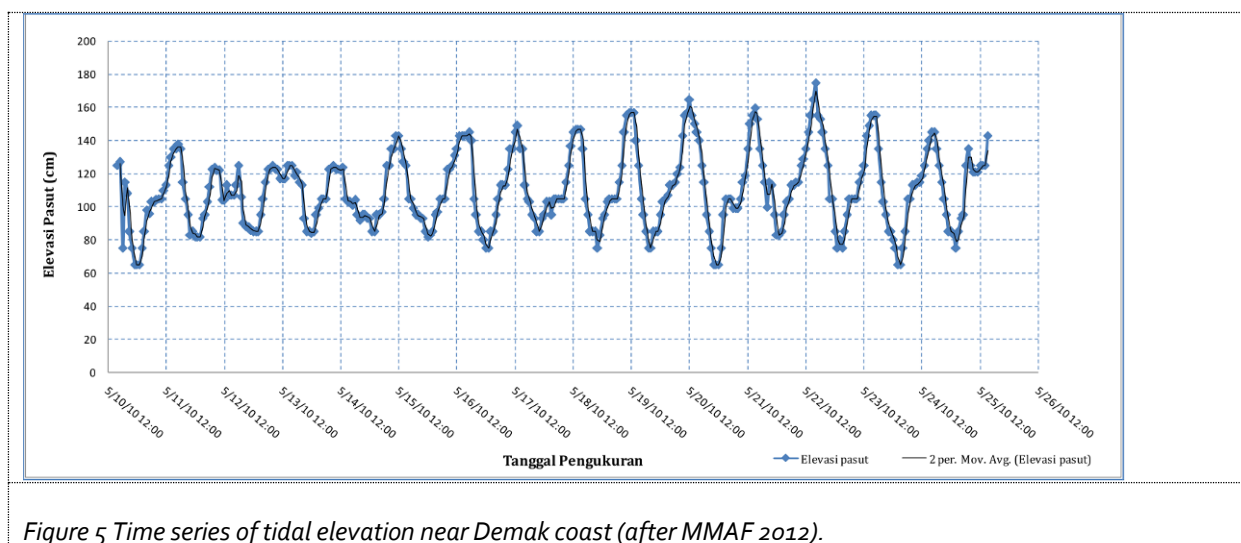
The tide near the Demak coastline depicts a pronounced diurnal signal, with a small semi-diurnal component (Figure 5). Neap-tide tidal range amounts to about 40 cm, whereas spring-tide tidal range amounts to about 60 cm, but can be a bit larger when the semi-diurnal components synchronize with the diurnal components¹⁵. Currents in Sayung coastal waters vary, with maximal velocities of around 15 cm/s^{16/17}. However, it is not known where these measurements were carried out. The majority of the measured currents appear to be directed in between East and South-East, which is more or less perpendicular to the Demak coastline.

Figure 5 Time series of tidal elevation near Demak coast (after MMAF 2012).

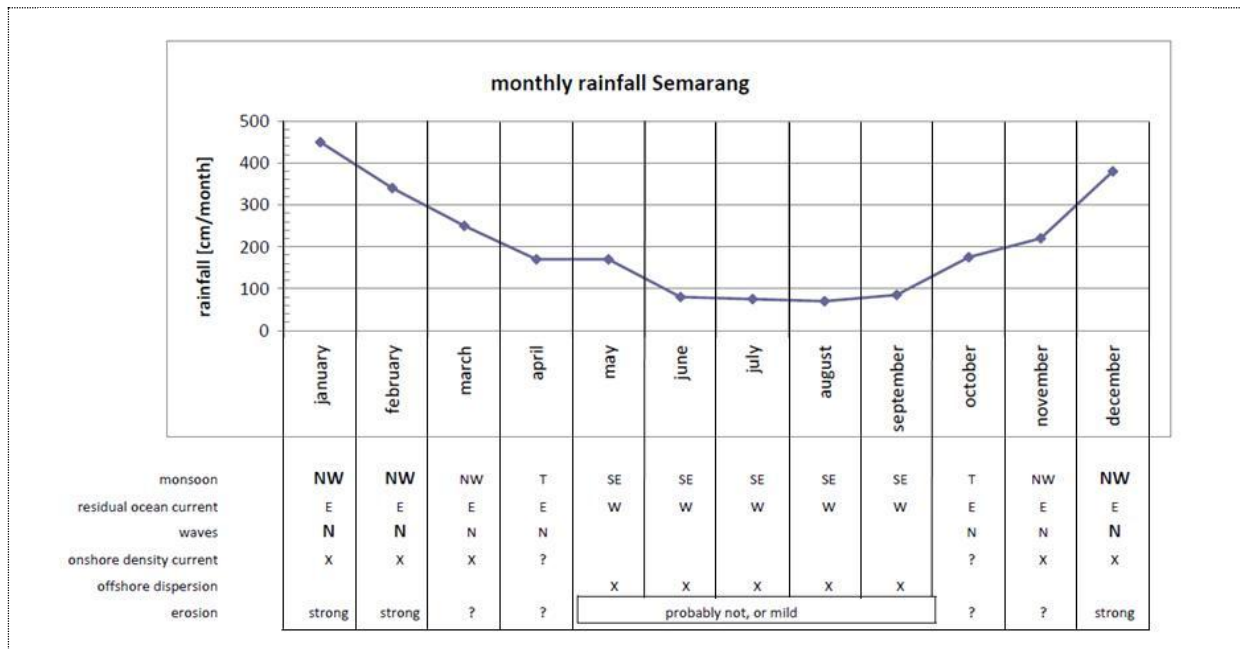
Rainfall distribution in Semarang²⁰ (Figure 5) can serve as a proxy for the distribution of the fresh water flow rate from the various rivers discharging into Demak coastal waters. The wind direction should have a profound effect on the dispersion of fresh water in the coastal waters. The wet season in Java is from about November through April, with December, January and February as the wettest months. During the NW-monsoon riverine fresh water plumes are pushed against the coastline, diverting to the East, following wind direction and residual currents. The fresh water distribution then induces a gravitational circulation along large parts of the coast, which keeps fine sediments close to that coast. On the other hand, during the SE-monsoon, which is the dry season (driest months June through August), fresh water is blown into the ocean (Java Sea) and the effects of gravitational circulations are much more localized. Then, no large-scale mechanism works to keep the fine sediments close to the coast.

Fig. 5: Rainfall distribution in Semarang (BayongTjasyono et al., 2008) and summary of conditions relevant for the fine sediment dynamics along Demak coast (bold = energetic/dynamic conditions)

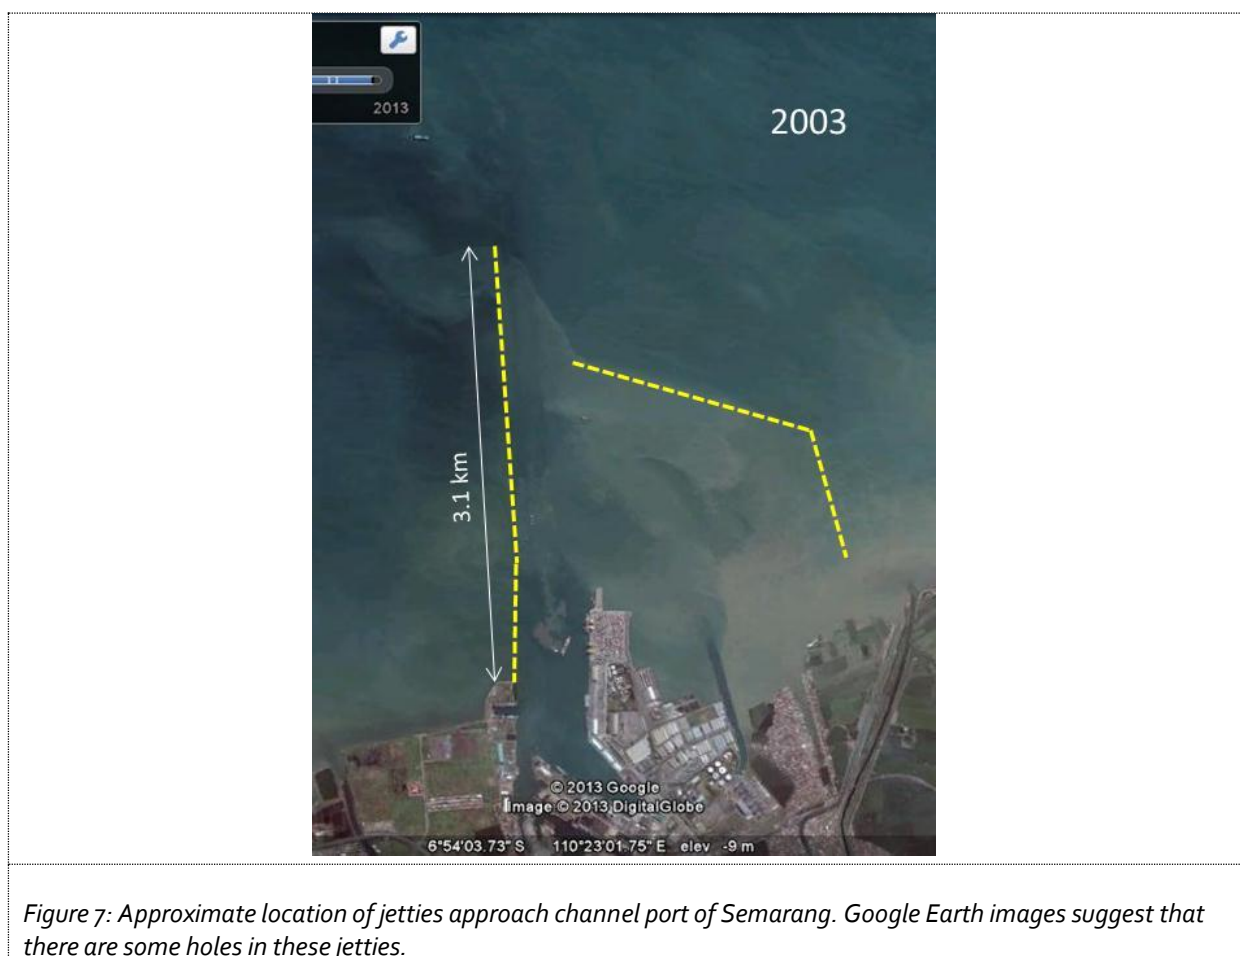
Coastal erosion can be caused by multiple factors amongst which the factors as described in section 4.1. However, direct anthropogenic influences in the environment, such as building of harbour piers and jetties and of coastal defences may have profound impact on coastal erosion and deposition patterns as well. For example, the jetties, protecting the port of Semarang, penetrate some 3 km into the sea (Figure 7), affecting eastward oriented residual fine sediment transports.

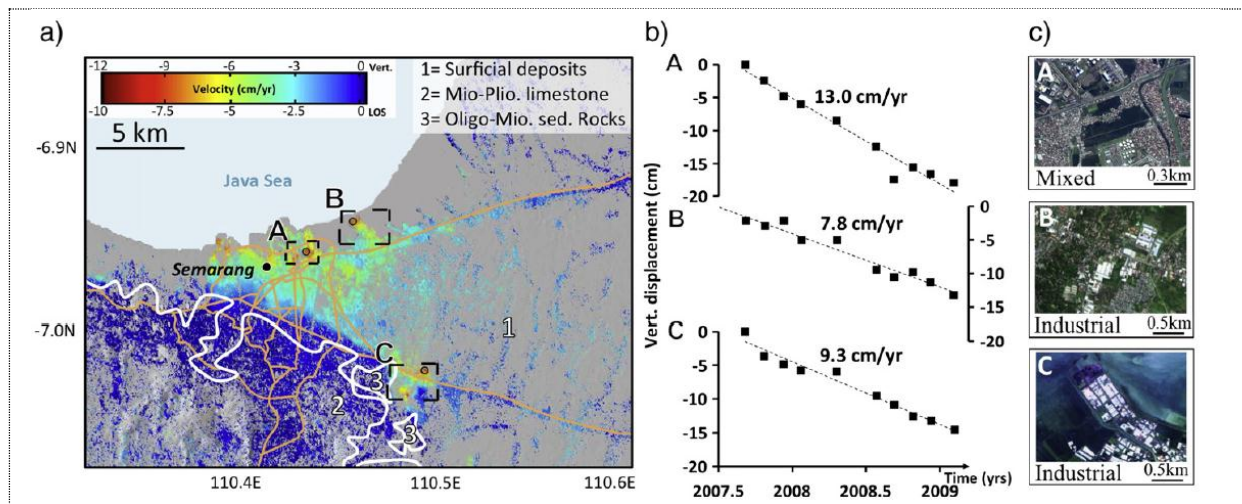
Figure 9 Subsidence observed near Semarang. a) Average 2007–2009 subsidence rate map. Roads are shown in light brown and main towns are labelled for reference. The contours of the geologic units are shown by white lines and referred to using white numbers. The black boxes show the locations of the Google Earth optical images displayed in c) corresponding to areas experiencing rapid subsidence. Black circles within the boxes show the location of the pixels whose time-series are shown in b). b) Vertical displacement time-series and corresponding linear rates of subsidence. c) Google Earth optical images showing the type of land use in rapidly subsiding areas²⁵.

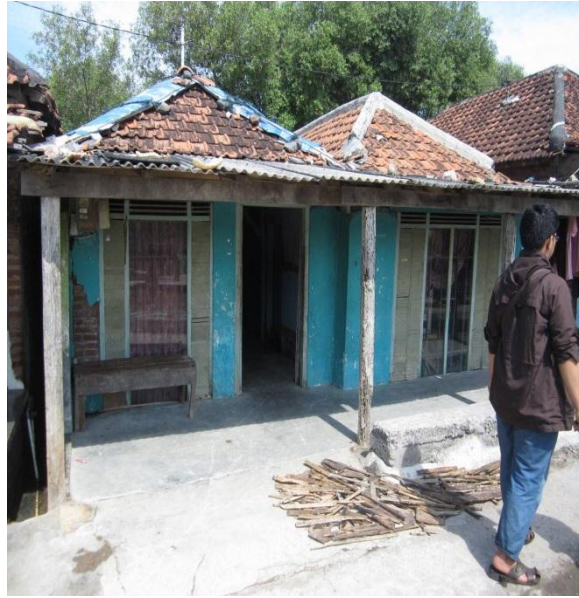
Figure 10 Houses close to the coastline in the Wonorejo part of Timbuloko. The height of the house points at the presence of subsidence (photo B.K. van Wesenbeeck).

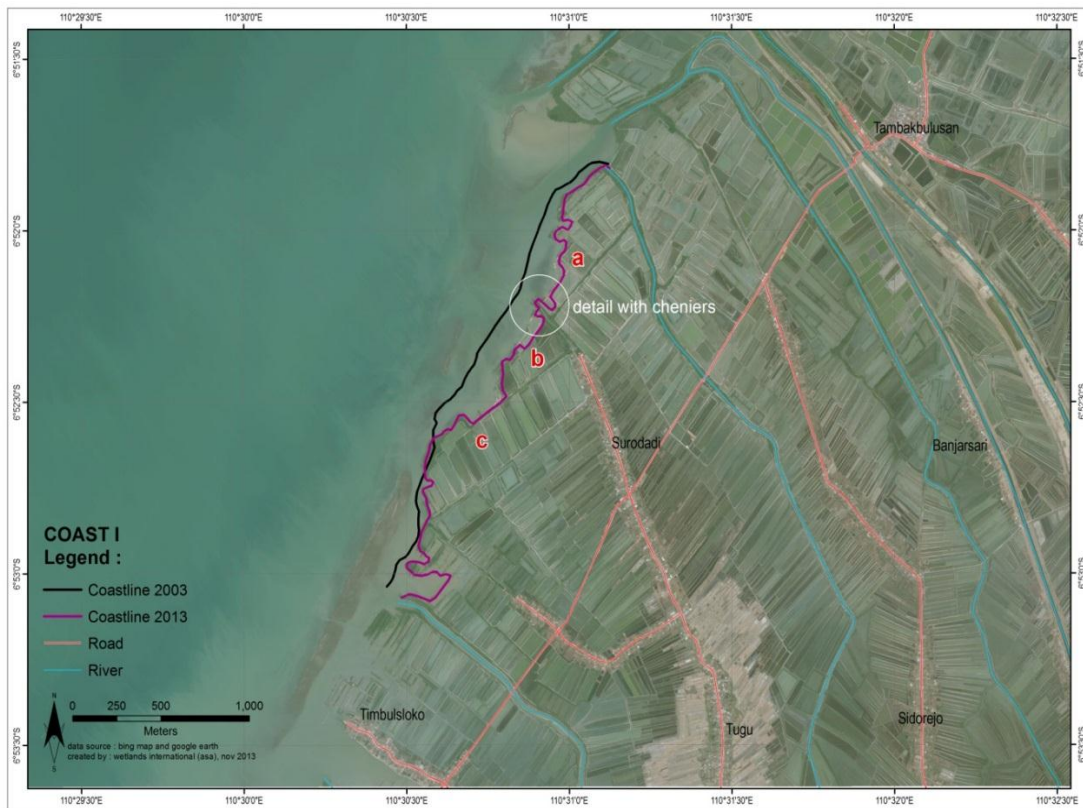
Figure 12 depicts the coastline of Demak coast I in 2003 and 2013, suggesting an erosion of about 100 – 300 m. The coastline seems to have retreated fairly regularly, except for three “cavities” (a, b, c), where erosion follows the lay-out of fish/shrimp ponds. Further zooming in with Google Earth suggests that most of this coastline is still fairly well protected by a series of cheniers (e.g. thin and narrow lenses of sand on top of the muddy seabed), indicated in Figure13 showing details of coast I.

Figure 12 Demak Coast I with approximate coastlines 2003 and 2013 (Google Earth images); see Figure 13 for details.

1. Create sheltered areas in the "cavities" a, b, and c (Figure 12) with permeable structures, similar to those presented in Chapter 4.3.
2. Build out the coast parallel to the 2013 coastline with permeable structures spaced about 100 m from each other, following the lay-out of former bunds for the foundation of the structures. We propose the following:
 - Application of different materials for the permeable structures in dialogue with local parties, including Boskalis'geohooks for one particular stretch;
 - Enhancing the suspended fine sediment concentration in the foreshore by mechanical means (mechanical agitation of the seabed).

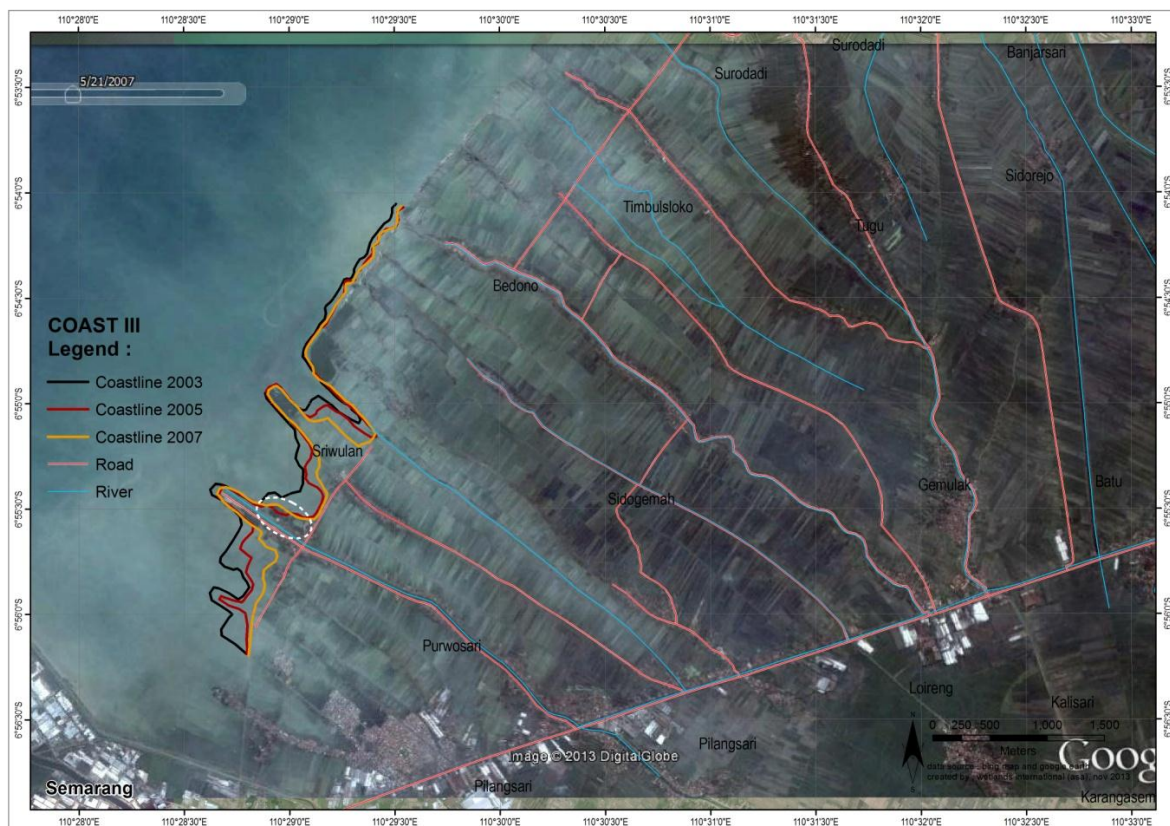
Figure 15 Demak coast III, showing the approximate coastline in 2003, 2005 and 2007 (Google Earth Images).

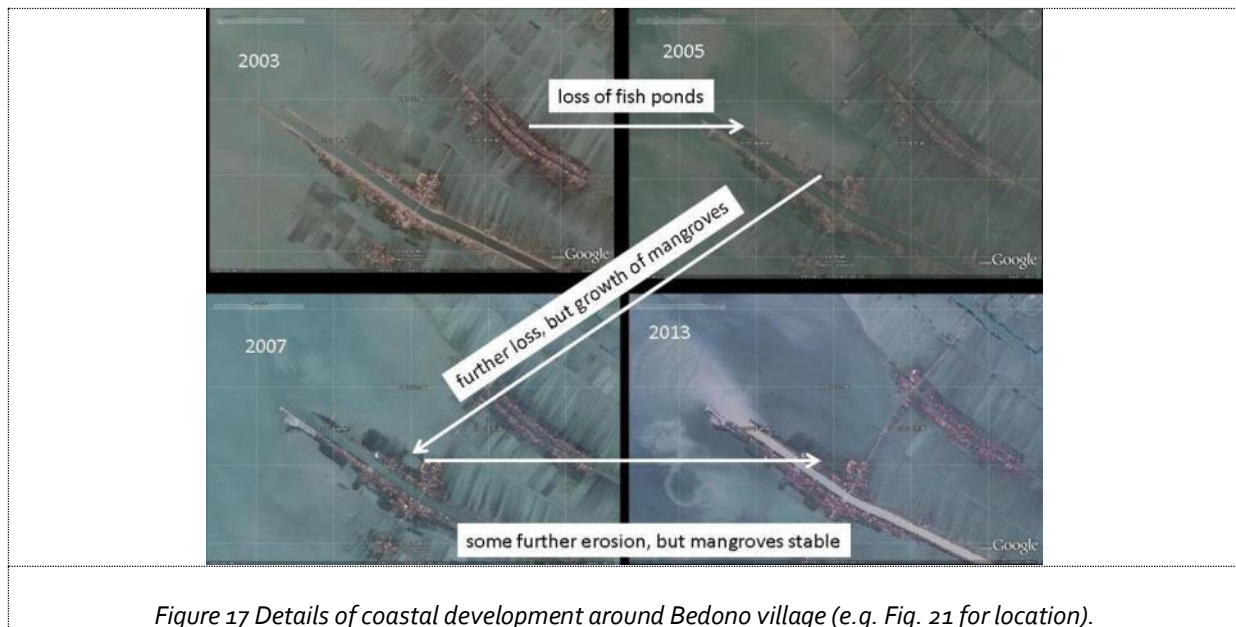
Figure 17 Details of coastal development around Bedono village (e.g. Fig. 21 for location).

Figure 17 zooms in on the evolution around Bedono village. The important observation here is that after the loss of fish ponds, mangroves seem to recover where conditions are favourable, i.e. in sheltered areas. This recovery has been observed at other locations around Demak district as well, in particular around Bogorame. In sheltered and rapidly accreting areas (often in between still present bund of eroding fish ponds that are filled with sediment) natural recovery of *Avicennia marina* has been observed (pers. obs.).

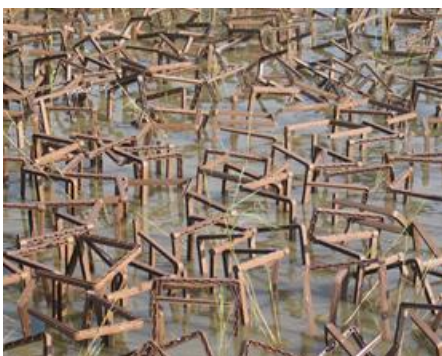
Alternatively, Geohooks may be tested. These are slender one-dimensional structures bent along seven ribbons of a cube, made of bio-degradable material (Figure 20). Geohooks become intertwined, forming a stable, semi-permeable structure.

Figure 20 Geohooks

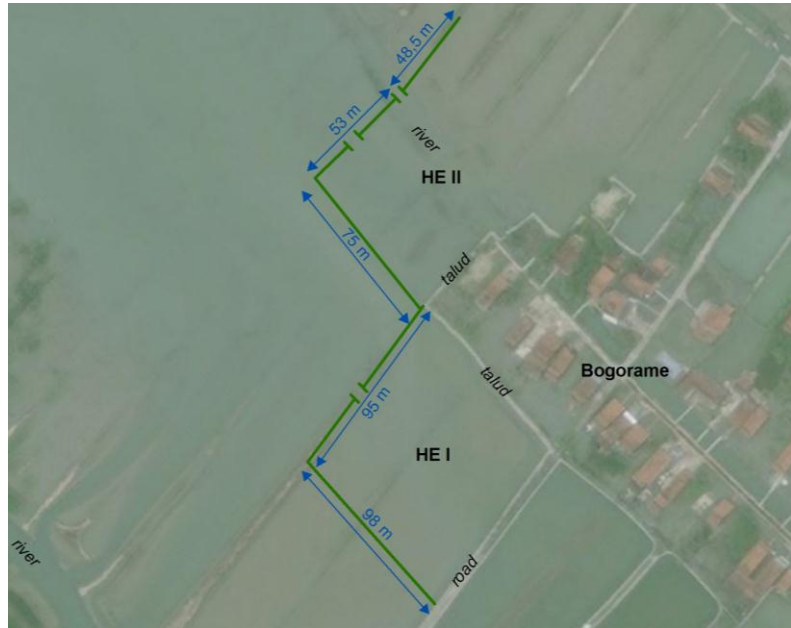
Figure 21 Design of two permeable structure grids at the coastline of Bogorame.

breakwaters may interfere with sediment transport to the coast and thereby influence the effectiveness of the permeable structures. The layout of permeable structures in grids for this location is presented in Figure 21.

We recently started prototype testing this approach together with MMAF, Diponegoro University and local NGO Kesematand we include the applied layout of permeable structures here as an example. Coastal erosion in sub village Bogorame has already proceeded until the road and also the village itself is severely threatened. No breakwaters were yet constructed in front of the coast which is an advantage since

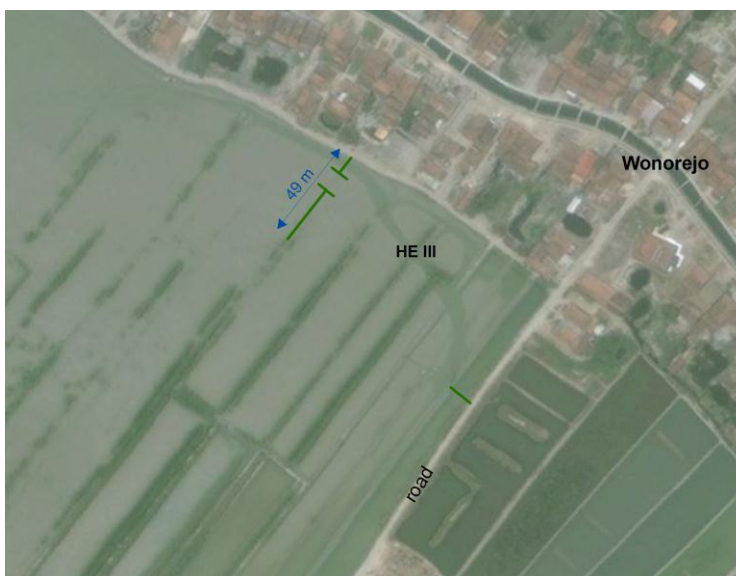
In sub village Wonorejo apply a different layout since the area is more fragmented. The area West of Wonorejo is already heavily influenced by planting of Rhizophora on old bunds of shrimp ponds. Certain plantings of Rhizophora are growing rapidly and are forming lines in the landscape. In between these lines, old fish ponds have filled in with sediment, especially those ponds bordering the river. Note that this may also be caused by the fact that these ponds are protected and not fully exposed to most heavy wind and wave directions. In the areas that filled in with sediment, natural Avicennia recruitment can be observed. As fetch in this area is not so large, while erosion in the area

Figure 22. Design of permeable structure near Wonorejo.

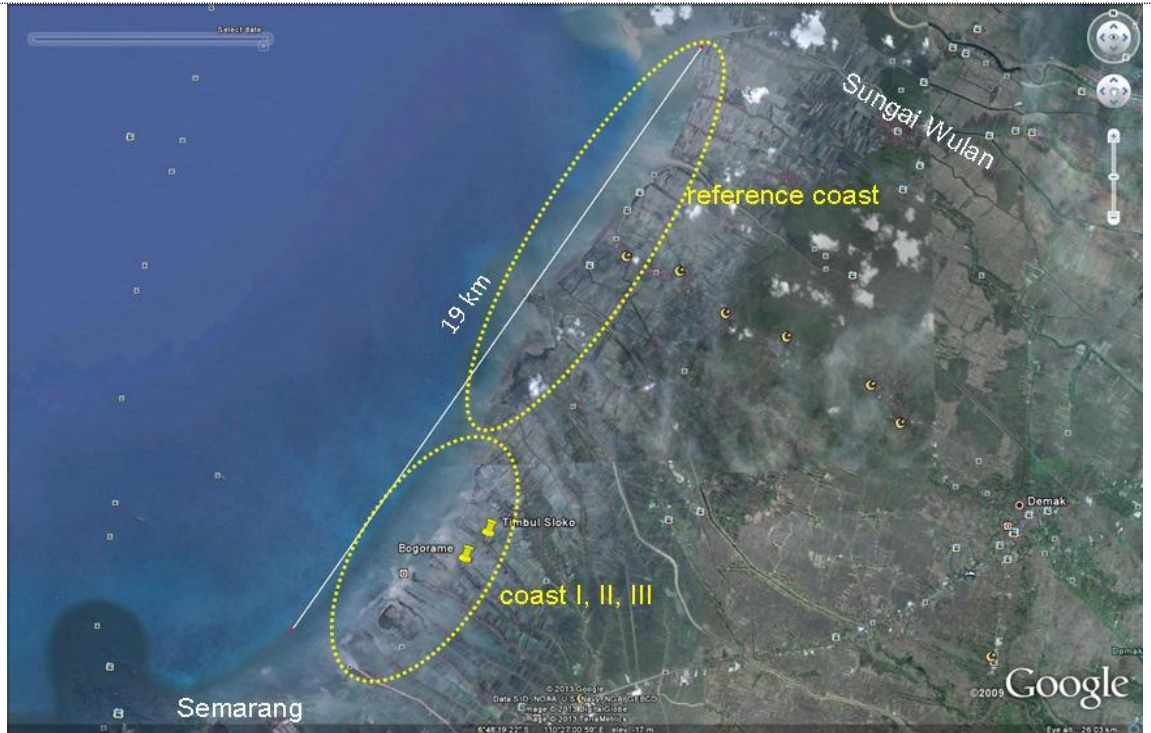
Demak coastline – coastal stretch of 19 km for large-scale Hybrid Engineering pilot (2013 Google Earth satellite image).

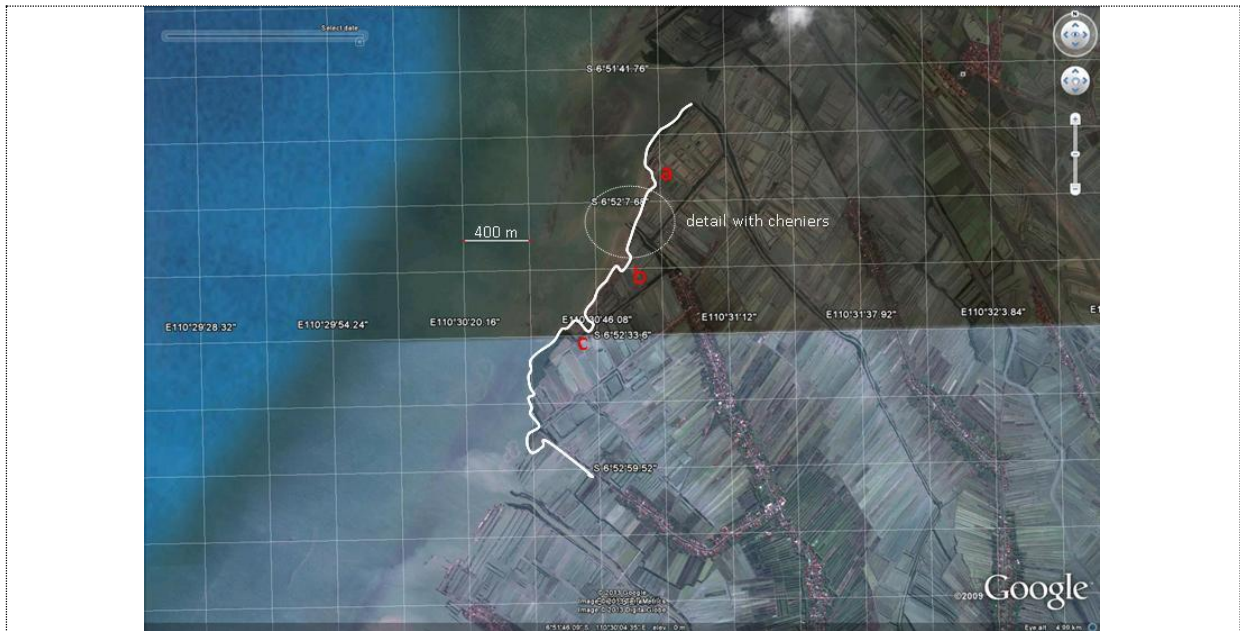
Demak coastline; coast I with approximate coastline 2013

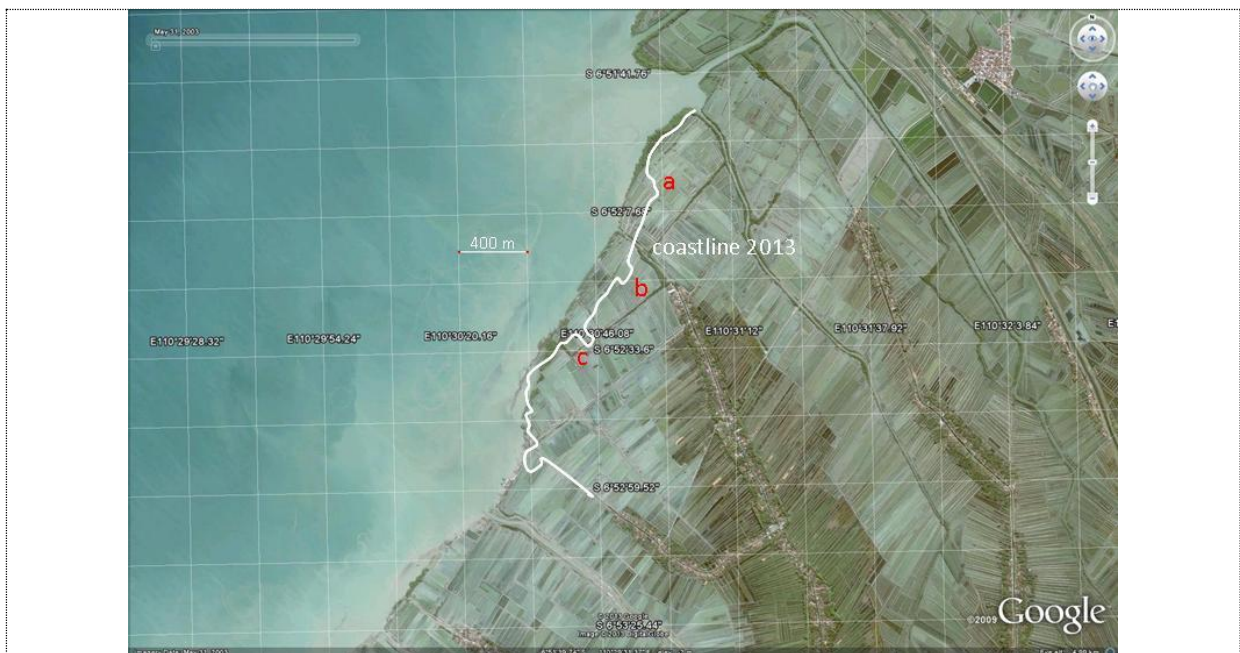
Demak coastline; coast I with approximate coastline 2013.

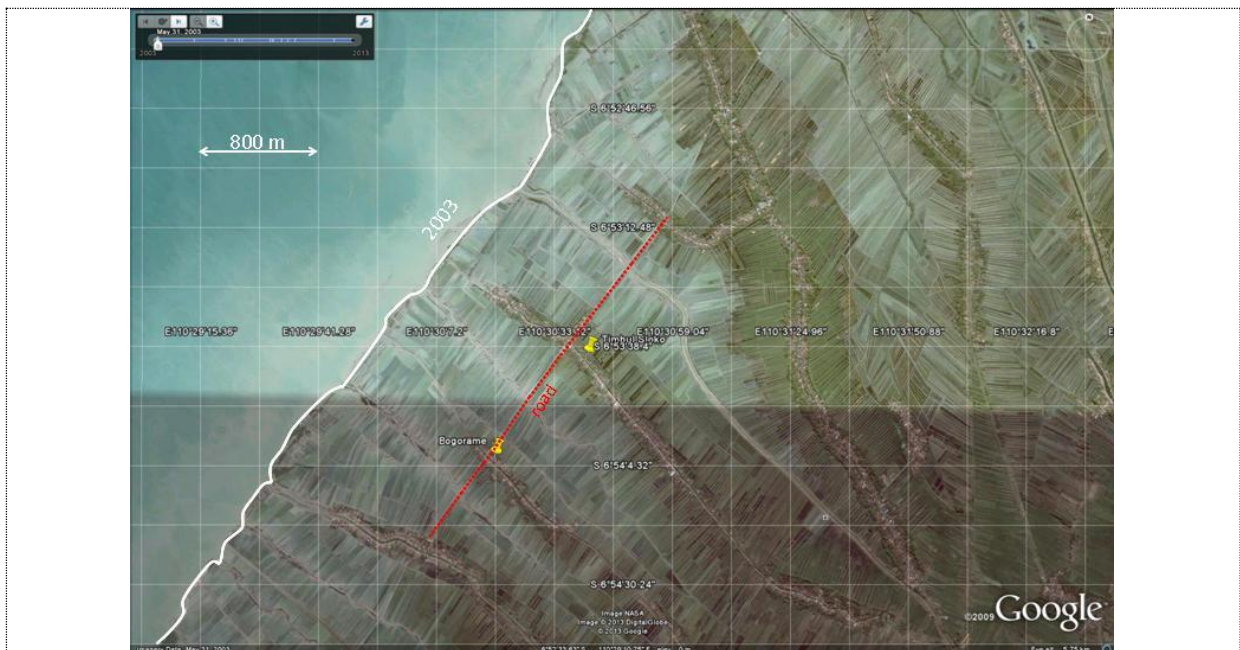
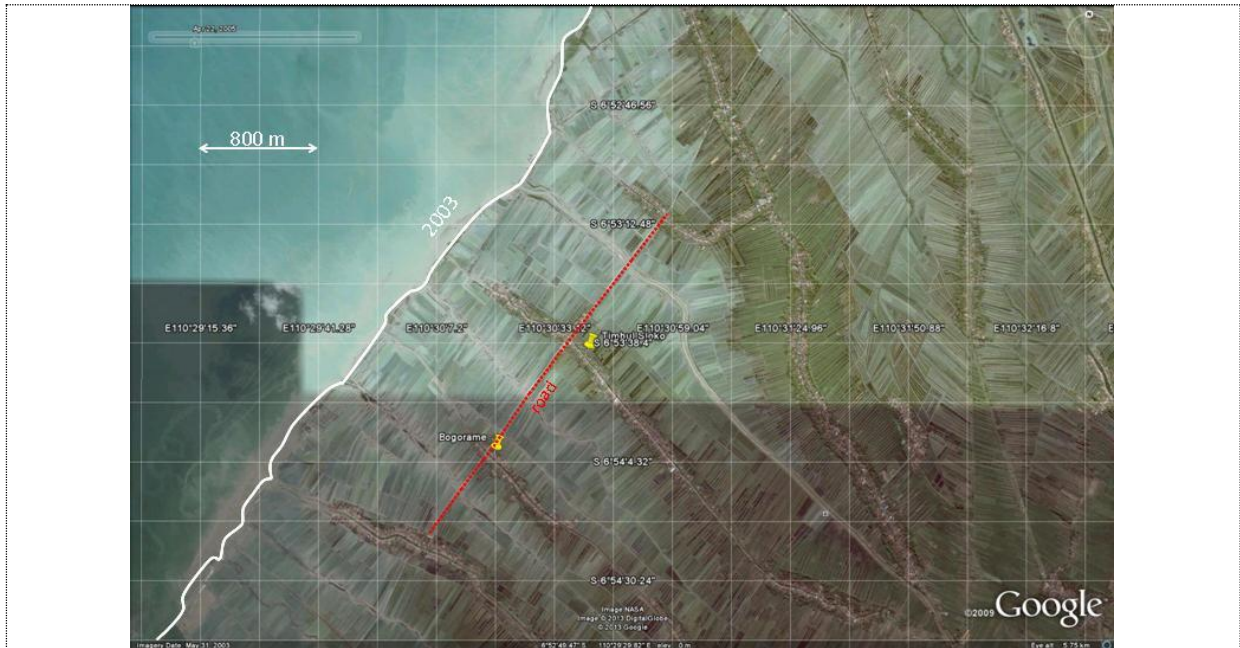
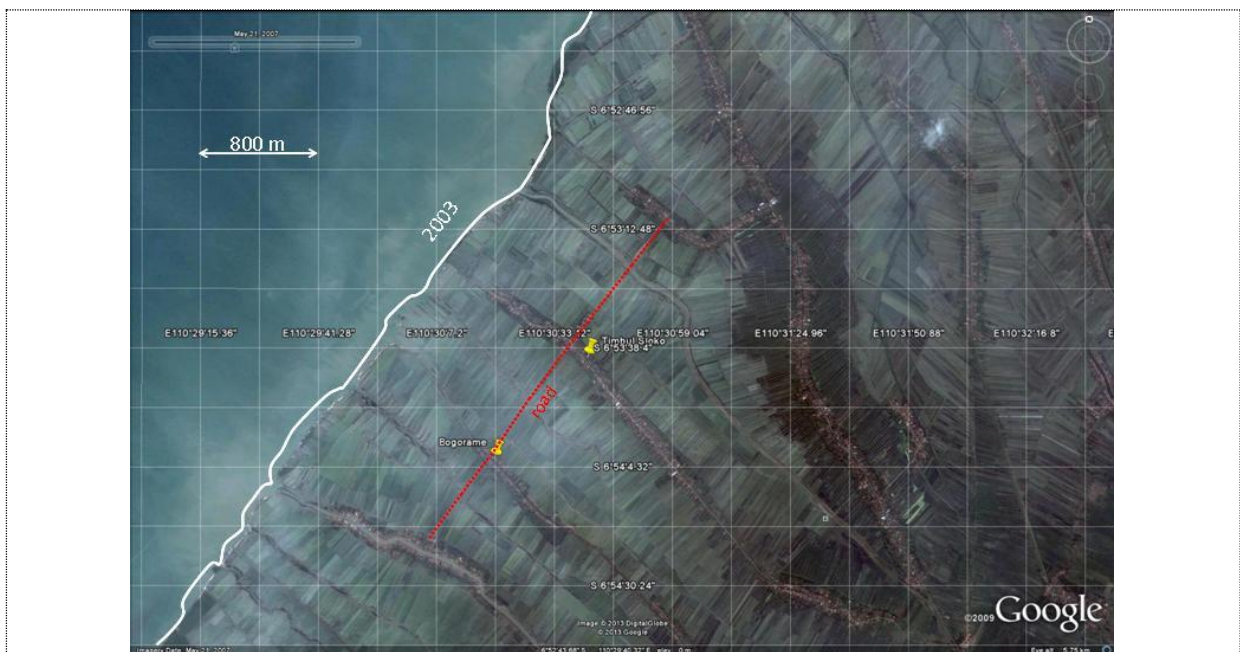
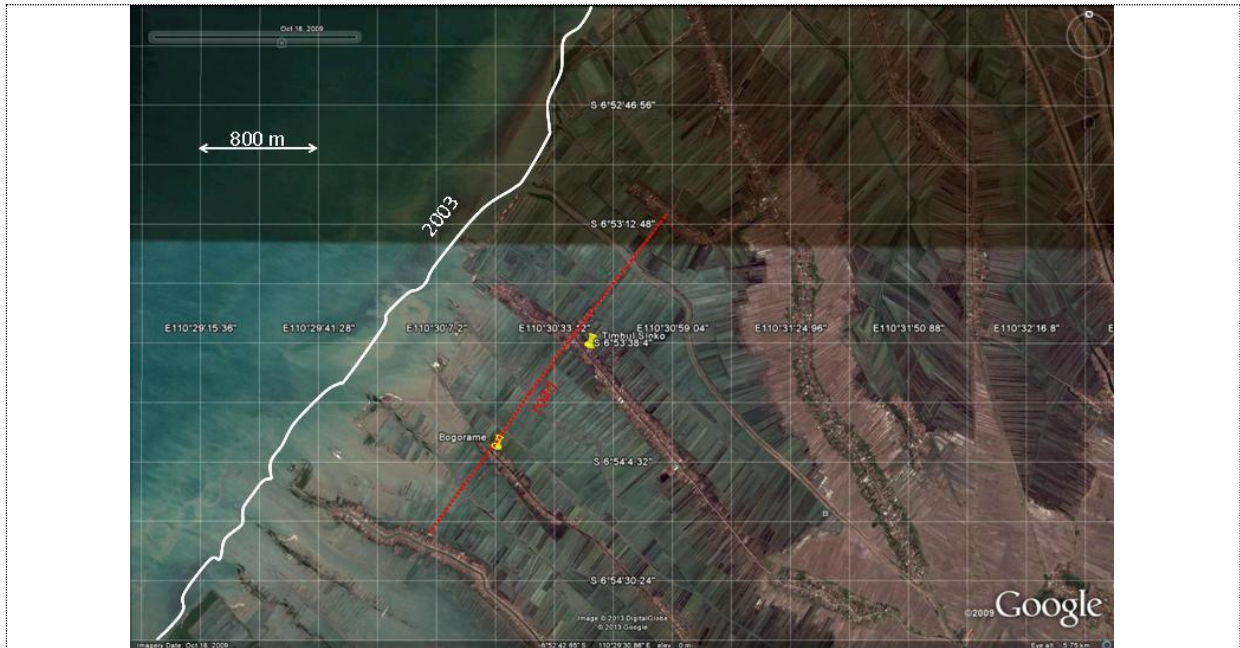
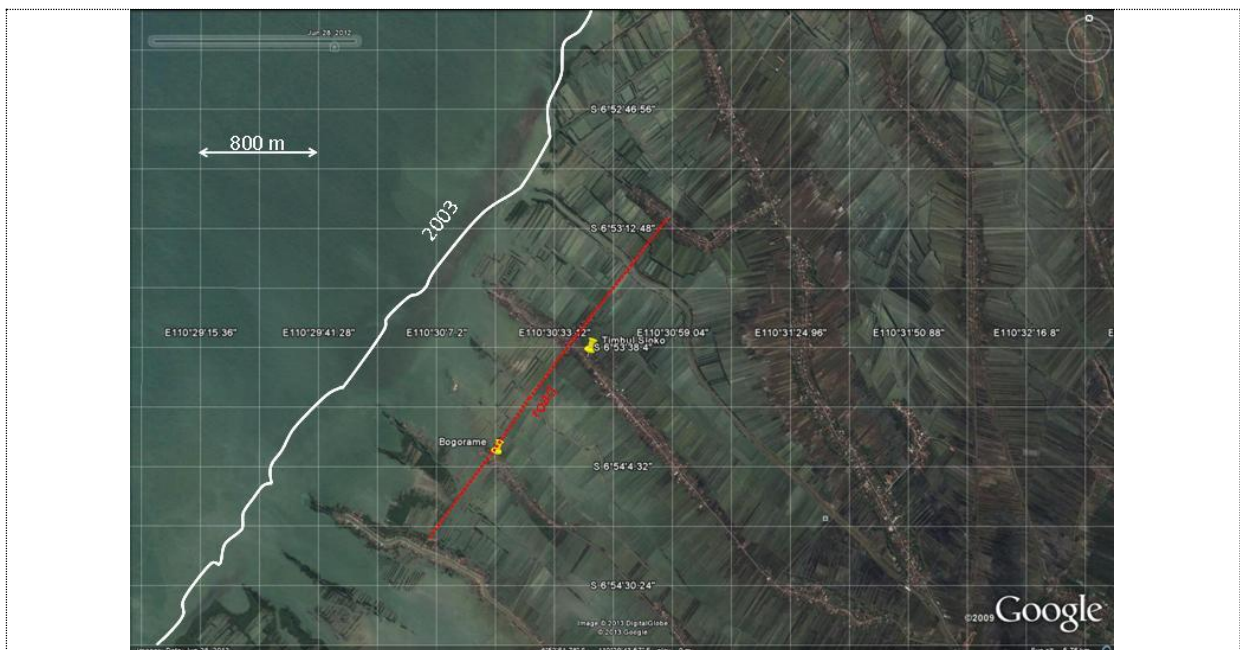
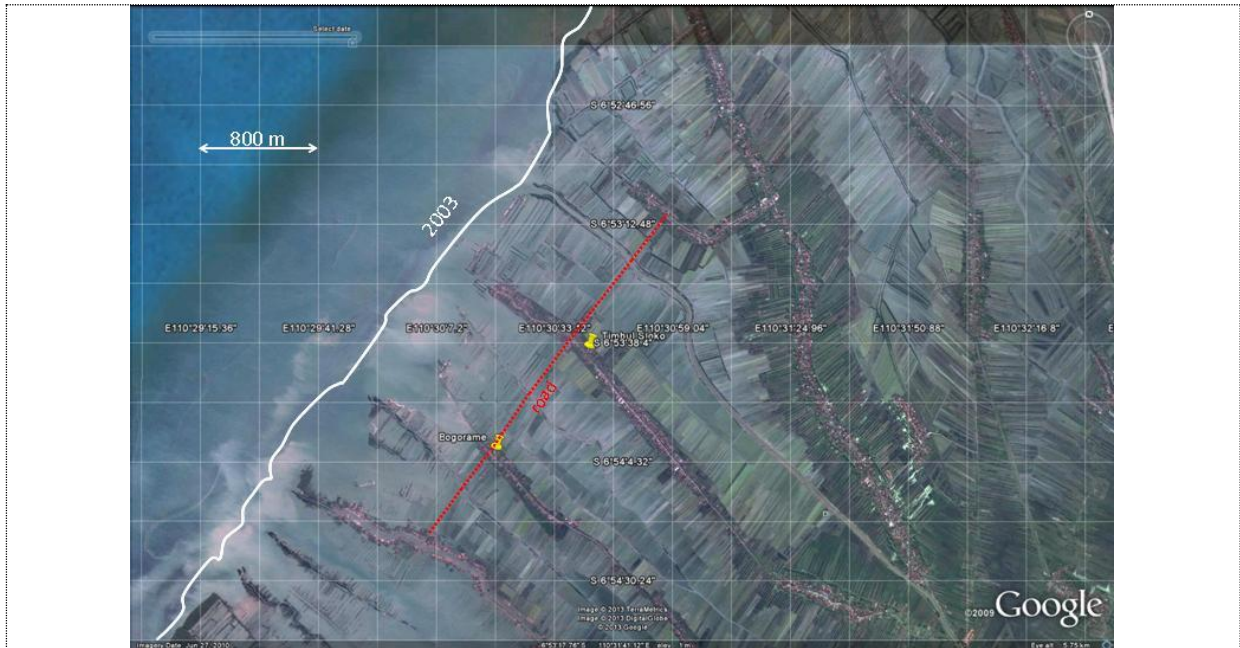
Demak coastline; coast II – 2003

Demak coastline; coast II – 2007

Demak coastline; coast II – 2009

Demak coastline; coast II – 2012

Demak coastline; coast II – 2013

Figure 14 presents Google images of Demak coast, coast II in 2003, 2005, 2007, 2009, 2012 and 2013. We have indicated the coastline in 2003 in all figures. Up to 2007, the coastline is fairly stable, with some erosion. In between 2007 and 2009, the coastline has retreated largely, by many hundreds of meters, at locations up to 1 km. This big response might be attributed to the larger waves in 2009 (e.g. Section 4.2). However, there may be other causes:

Figure 14 shows that erosion is difficult to control from 2009 onwards, and land is continuously lost. The road connecting Wonorejo and Bogorame sub village now seem to control further erosion of the hinterland. However, signs of deterioration of the road are already visible. In certain parts the road is almost continuously submerged (except for very low tides) and in other parts erosion of the road is clearly visible. Safeguarding this road seems a vital step in stopping erosion from proceeding further inland. The road can be protected by placing permeable groin structures in front of the road. However, the main construction and the base of the road should be improved simultaneously.

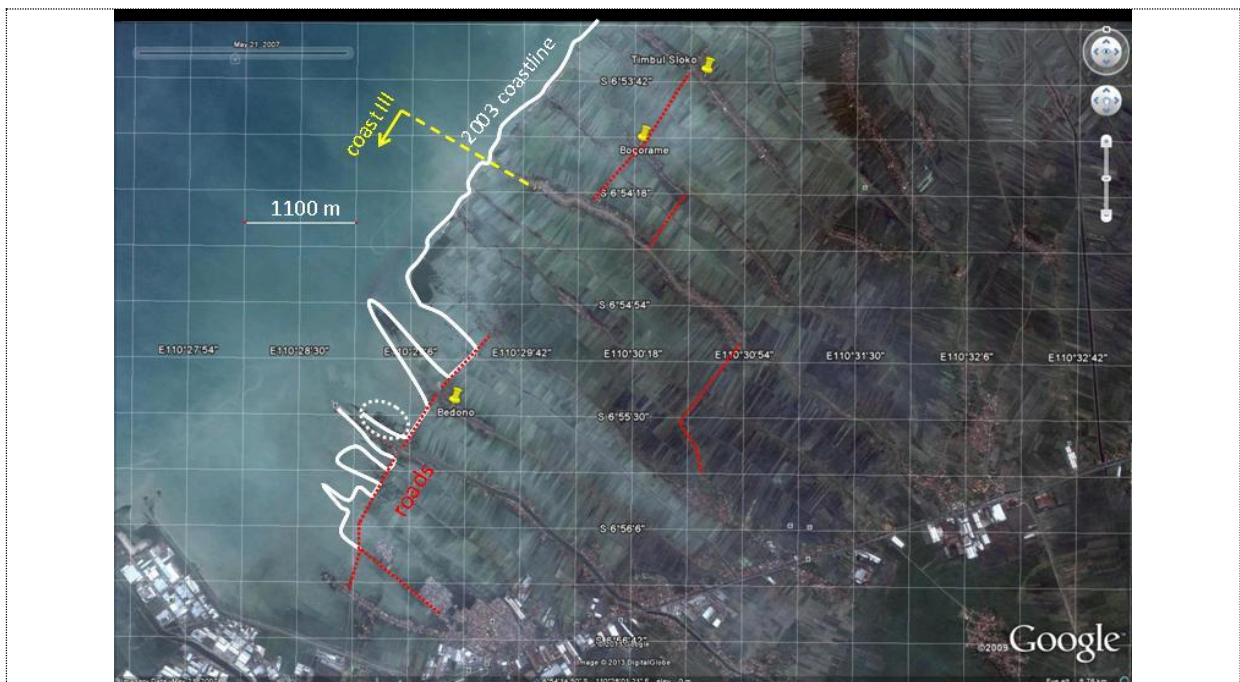
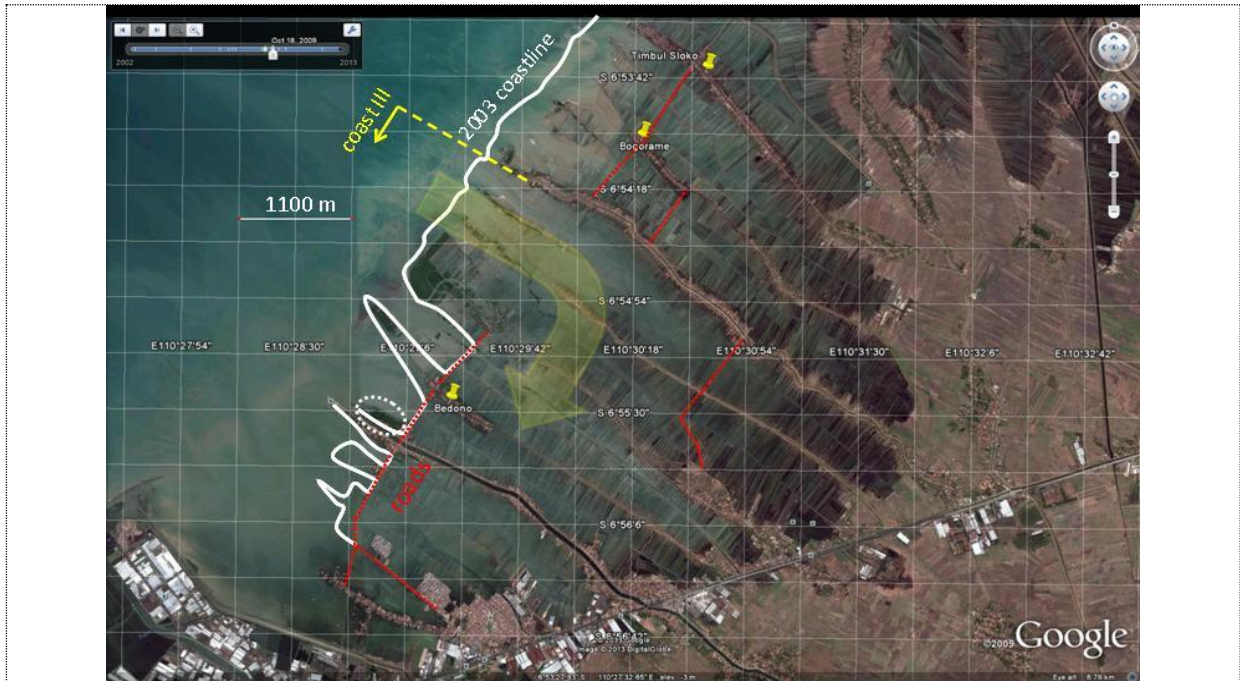
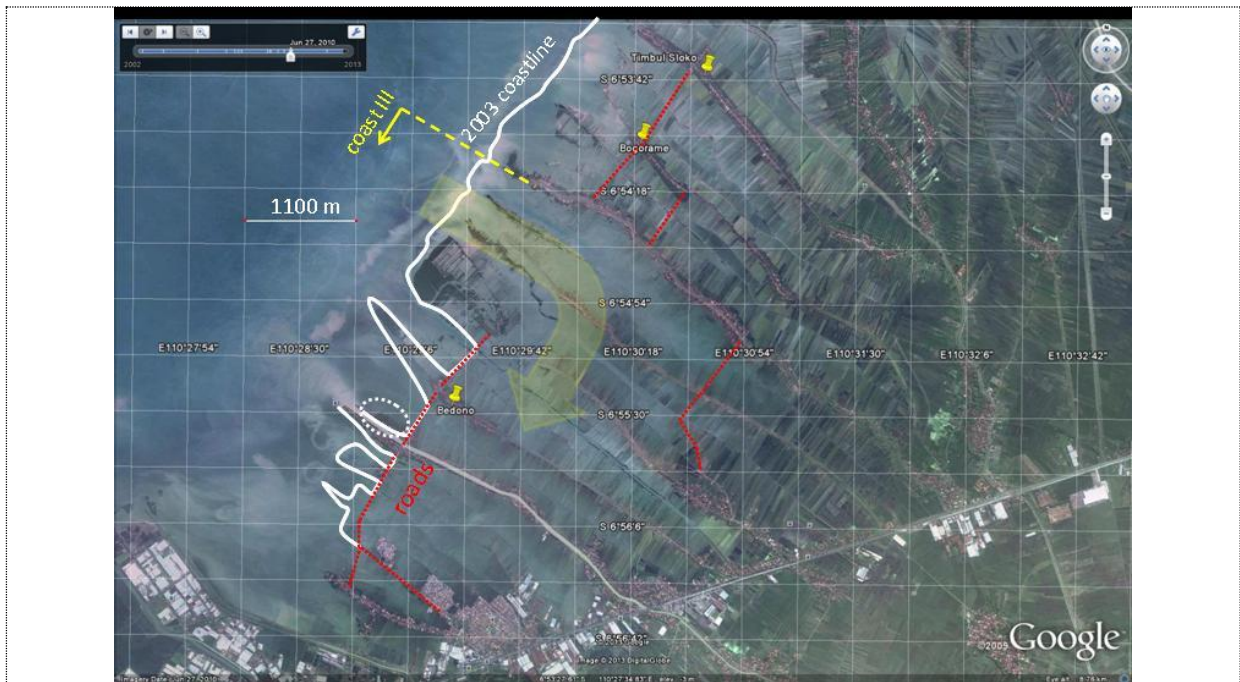
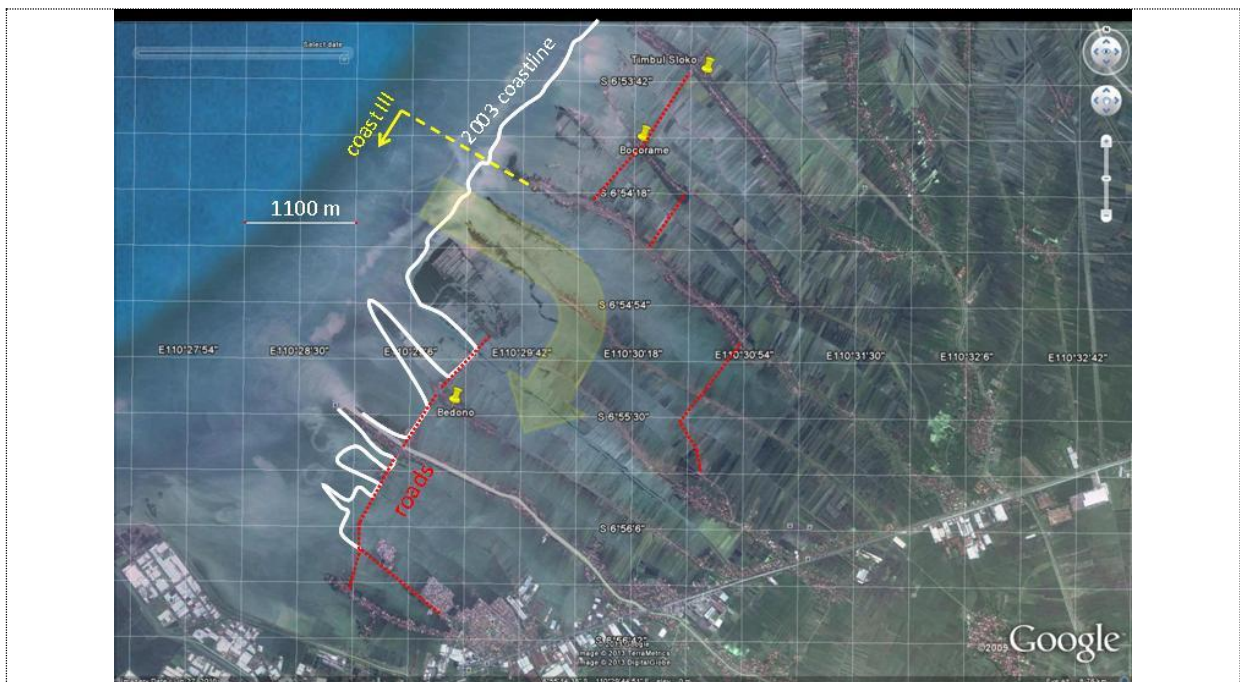
Demak coastline; coast III – 2007

Demak coastline; coast III – 2009

Demak coastline; coast III – 2010

Demak coastline; coast III – 2013.
