Defining Eco-Morphodynamic Requirements for Rehabilitating Eroding Mangrove-Mud Coasts

J. C. Winterwerp · P. L. A. Erftemeijer ·
N. Suryadiputra · P. van Eijk · Liquan Zhang

Received: 4 August 2012 / Accepted: 8 March 2013 / Published online: 29 March 2013
© Society of Wetland Scientists 2013

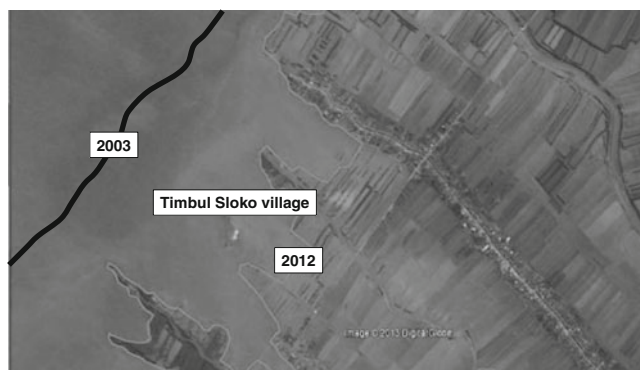
Fig. 2 Coastline changes in Demak District (Timbul Sloko village, Central Java, just east of Semarang) between 2003 and 2012 estimated land loss 200 – 900 m (source: *Google Earth*)

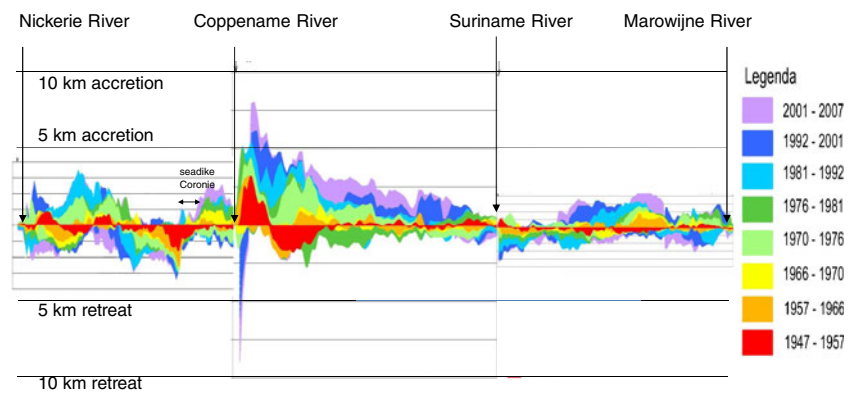
Fig. 3 Alternating retreat and accretion of Suriname's 300 km coastline since 1947, over eight periods of time (redrawn from Augustinus 2004). Note cyclic variations both in space and time. Most of the coast accretes over longer periods of time, except near Paramaribo (located along the Suriname River, and Coronie coast where more than 5 km erosion has been observed since 1900

The (im)balance between sedimentation and erosion processes is well-illustrated in the alternating accretion and retreat of the mangrove-fringed coastline of **Suriname** (Augustinus 2004; Erfteemeijer and Teunissen 2009). Figure 3 shows spatial and temporal variations that synchronize with large, 30 – 50 km long mud banks, migrating along Suriname’s coast at a rate of about 1 – 3 km/year with a periodicity of about 30 years (Augustinus 1978; Plaziat and Augustinus 2004). In between mudbanks, the coast erodes, otherwise, accretion occurs, with a general net accretion over longer periods of time (multiple decades). The coastal stretch around Coronie (Fig. 3) however is characterized by long-term erosion since

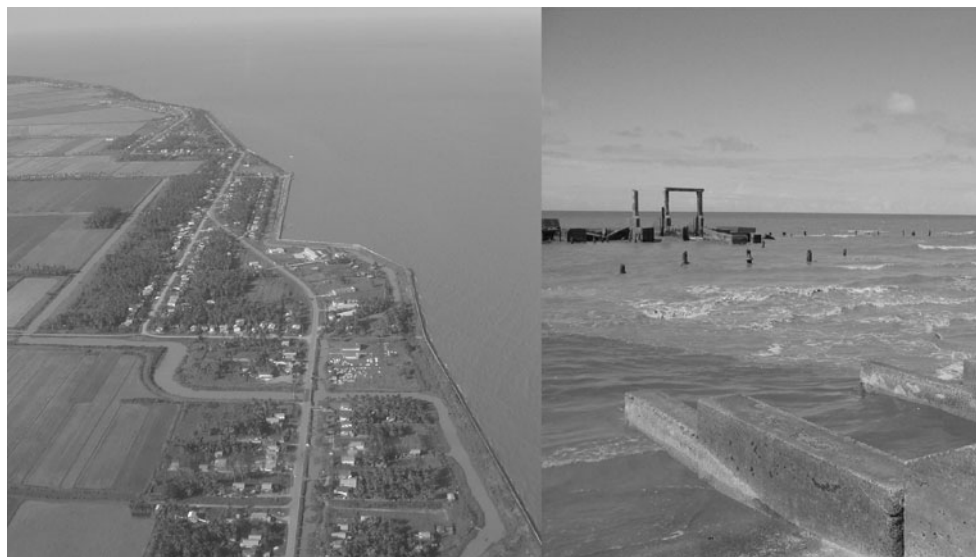
Fig. 5 Guyana mud coast around Georgetown. All mangroves have disappeared by ‘hard’ sea defences, resulting in severe coastal erosion, as shown from the abandoned sluice systems

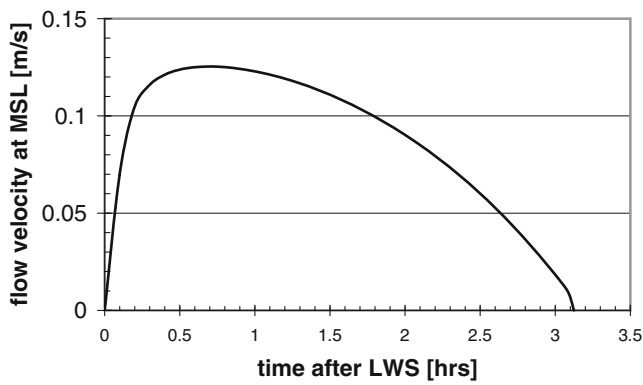
Fig. 7 Flow velocity over undisturbed mudflat computed at $x=1,000$ m (MSL, e.g. Fig. 6) as a result of tidal filling

where h =water depth, u =flow velocity, t =time and x =coordinate along the mudflat. The resulting flow velocity at mean sea level (MSL) is presented in Fig. 7, showing flow velocities slightly exceeding 0.1 m/s. Indeed, these are typical velocities over tidal flats.

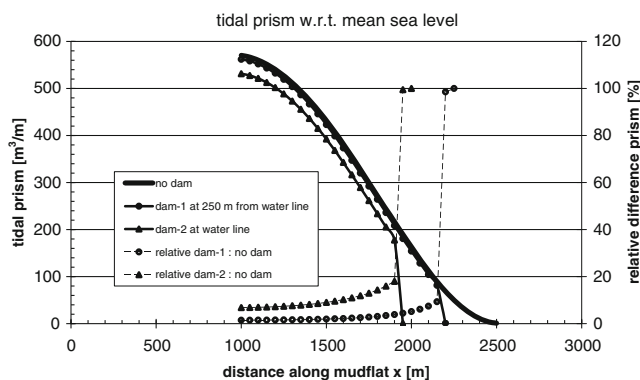
Fig. 8 Computed tidal prism P_T starting at mean sea level, along mudflat with and without dam at $x=2,200$ m (250 m from waterline) and at $x=1,950$ m (at high-waterline)

Integration of this flow velocity over depth and flood period yields the tidal prism P_T per unit width [m^3/m'], i.e. the amount of water flowing towards the coast at location x . This can be done for all locations along the mudflat. The resulting $P_T - x$ graph is given in Fig. 8, showing $P_T \approx 560 \text{ m}^3/\text{m}'$ at $x=1,000$ m (MSL) and $P_T=0$ at the top of the mudflat ($x=2,500$ m).

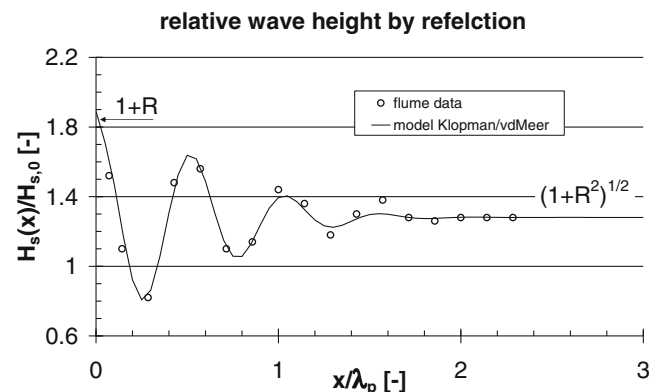
Fig. 9 Wave reflection against hard, impermeable structure (redrawn from Klopman and van der Meer 1999); R =reflection coefficient

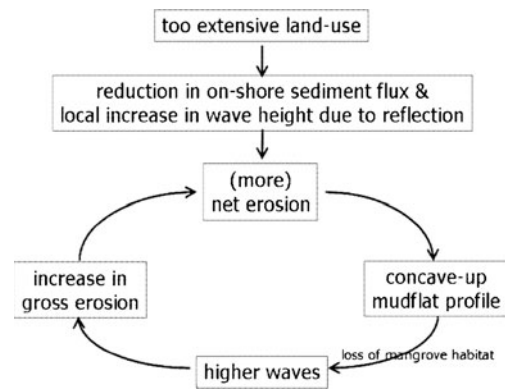
Fig. 11 Snowball effect for coastal erosion of mangrove-mud coasts induced by thoughtless land-use, such as extensive erection of fish/shrimp ponds

The simple coastline Eq. (4) allows for a qualitative assessment of a feedback loop that occurs following conversion of mangroves and subsequent infrastructure development along mud-coasts. The initial response to this land-use change is a reduction in sediment flux towards the coast, and a local increase in wave height, as discussed above. Then, Eq. (4) implies that the eroding wave-induced forces are no longer compensated by onshore sediment transport. The coastline starts to retreat. Fringes of mangroves that remain in the disturbed area are slowly lost to the sea. This reduces sedimentation rates substantially, as less mangrove trunks and roots remain to capture sediments coming in with the tides. As the retreating coast then develops a large-scale concave-up cross-sectional profile, wave effects start to dominate the sediment dynamics (see Fig. 10; Friedrichs 2011; and many other publications). Then, water depths in front of the coastline increase further, and waves can penetrate further towards the coast, enhancing erosion further. Figure 11 shows a schematization of the interactions leading to this snowball effect.

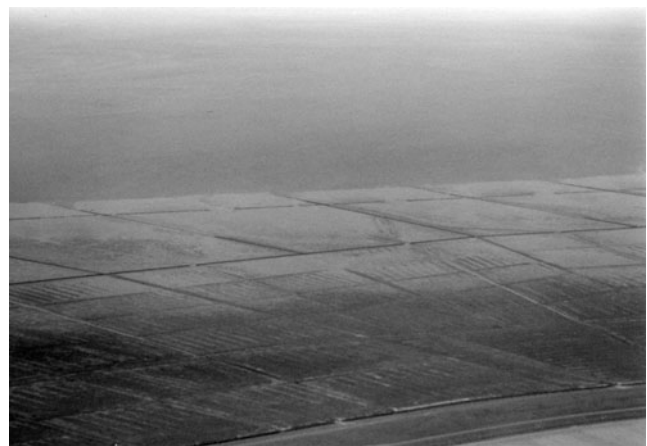
Fig. 12 Example of salt marsh works along the Wadden Sea (The Netherlands) – such salt marsh works, consisting of permeable groins made of willow twigs, have been deployed for many centuries, reclaiming substantial areas from the sea

2. Enhance trapping of fine sediments on the mudflat in a natural way, for instance through the use of ‘salt marsh works’ – i.e. erection of small, permeable groins (made of locally available materials such as brushwood, poles, bamboo and/or flexible twigs) in the intertidal zone to enhance sediment accretion, followed by the excavation of ditches to improve drainage and accelerate plant establishment (Bakker et al. 2002). An additional advantage of such artificial reclamation works is the local reduction in long-shore currents, reducing long-shore transport away from the rehabilitation site of fine sediments by these long-shore currents; an example is shown in Fig. 12 for temperate salt marshes. It is noted that the authors are not aware of any ‘salt marsh works’ in mangrove areas, but there is no reason to doubt their efficiency;
