Has the high water altered the bed of the Meuse?

Update: 31-8-2021

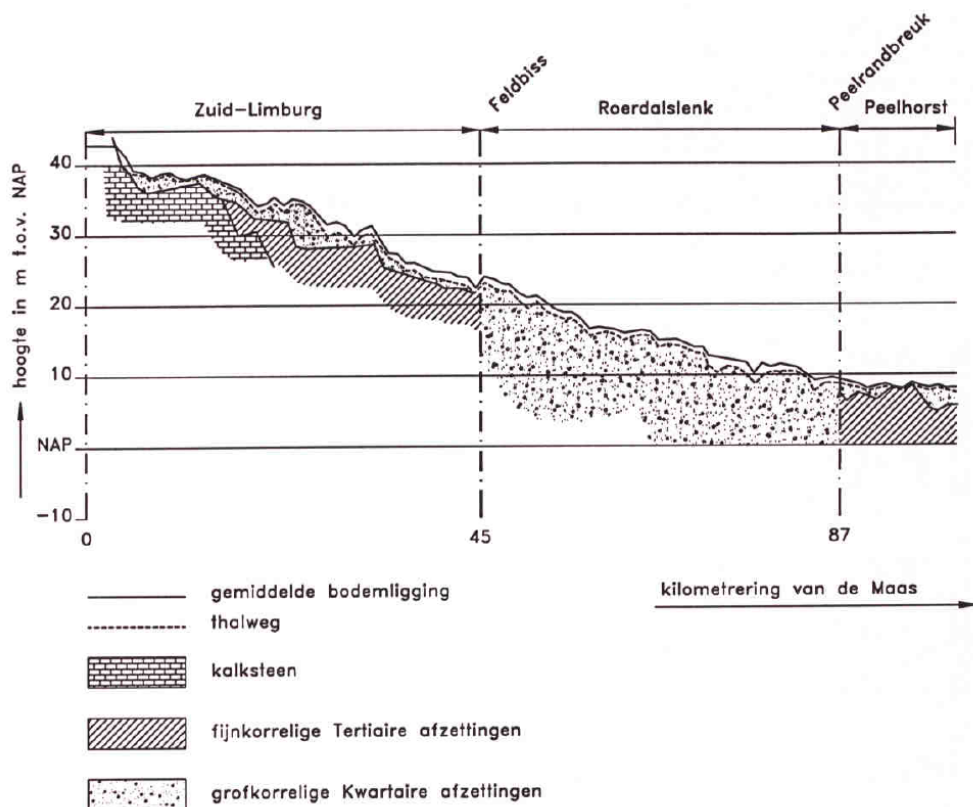
However, the bed does not recover naturally if the erosion occurs after a limit to the strength of a bed or bank has been exceeded. This is the case, for example, if a bank defence fails or if a thin layer of gravel starts to move and covers layers with finer sand. Deep scour holes can then form suddenly. In the steep and fast-flowing Grensmaas, this is a threat between kilometres 17 and 45, where fine-grained Tertiary sands are located close below the surface. As a result, various scour holes formed during the high water of July 2021. At Berg aan de Maas (km 38.9) the bed eroded to a level below

10 m NAP, resulting in a pit extending below the surrounding river bed to a depth equivalent to a four-storey flat.

Simplified geological longitudinal profile of the Meuse (Mosselman & Wang, 1994). Fine-grained Tertiary deposits are just under the surface of the river bed between kilometres 17 and km 45.
